COST SAVINGS AND AVAILABILITY IMPROVEMENT WITH GE's Gas Turbine

SPLIT CASING DESIGN FACILITATING IN-SITU REPAIR AND MAINTENANCE

**BY TIM OUTLAND,
DEL ROGERS, GEORGE AWISZUS
GE MARINE**

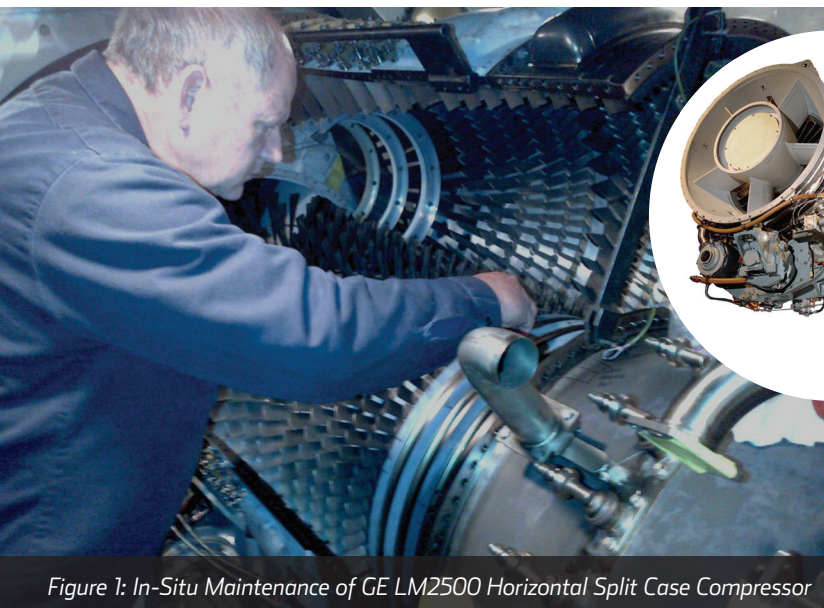
GE LM2500 and LM6000 gas turbine designs have horizontal split casings to facilitate easy access, repair and maintenance to internal components.

Figure 1: In-Situ Maintenance of GE LM2500 Horizontal Split Case Compressor

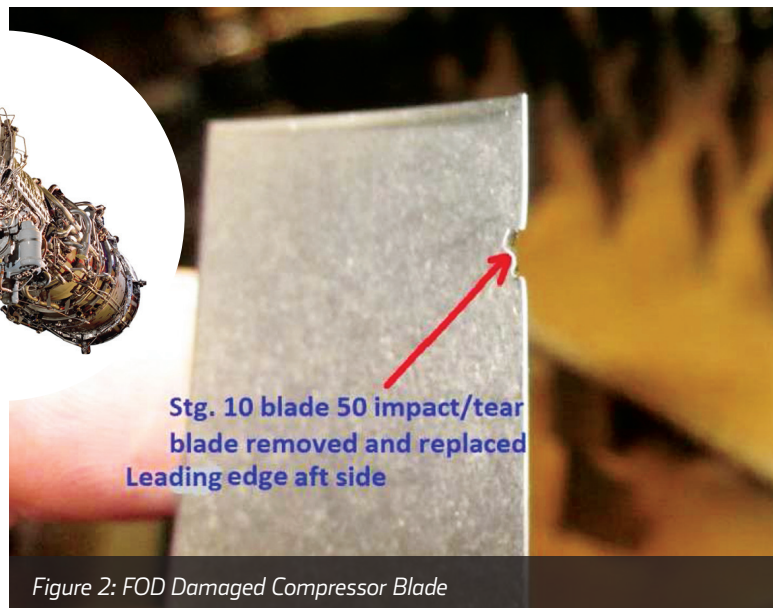
Figure 2: FOD Damaged Compressor Blade

Figure 2 illustrates a compressor blade that experienced an impact/tear from a FOD event. The blade was determined to be beyond serviceable limits and required replacement.
